# Manhole Inspection Summary

Manhole # S45GG\_054MH

Insp Date: **3/13/08 9:22 AM**

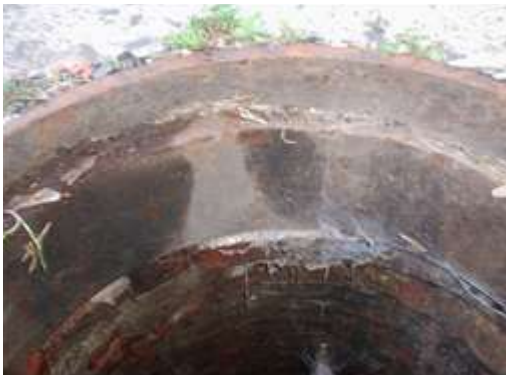
Defect 1

☒ **Leaks**

Frame leaks.

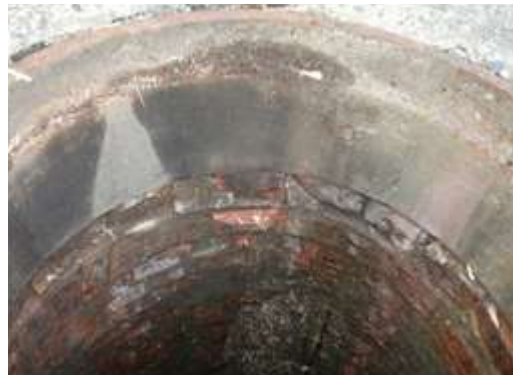
Defect 2

Condition: ☐ Sound ☐ Cracked ☐ Root Intrusion ☒ **Loose Brick** ☐ Deteriorated

Loose bricks.

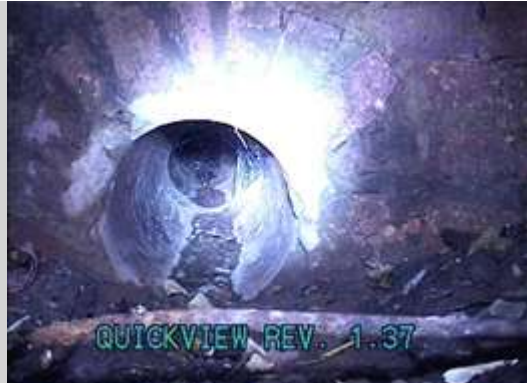
12 O'Clock Outflow

8 in. Circular Gravity Sewer  
Pipe Out @ 12 O'Clock

Deposits: ☐ None ☒ **Mud** ☐ Sludge ☒ **Debris** ☐ Grease

Silt Depth: **1** (in.) Deposits Extent: **Light**
